Replacement Reserve Study
DUNN LORING VILLAGE

RSTUDY+
REPLACEMENT RESERVE STUDY

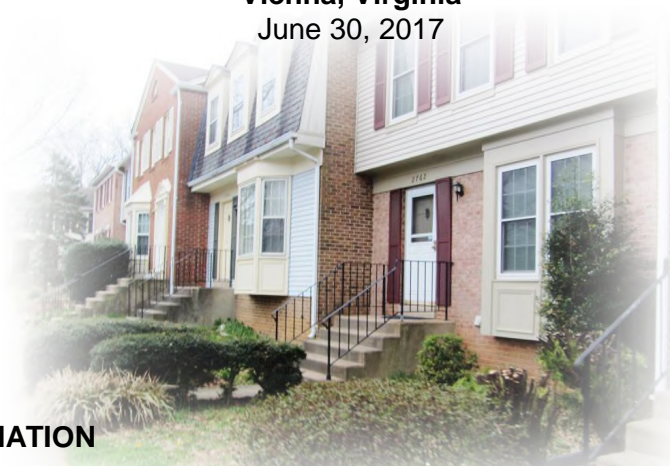
A. GENERAL INFORMATION

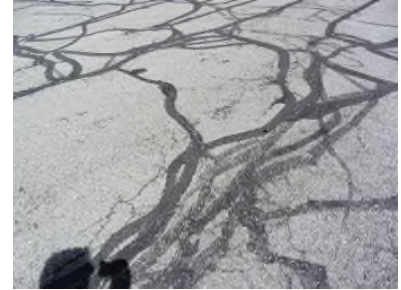
These projects are scheduled in the *Replacement Reserve Inventory* and have an estimated cost of \$726,270 in the first five years of the Study Period.

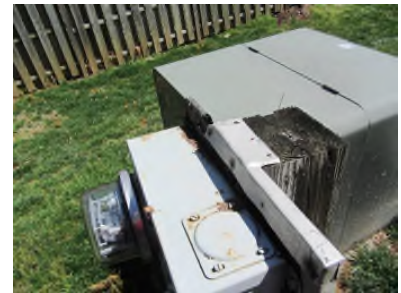
Safety defects. Several of the defects in the *List of Recommend Repairs* are safety hazards and should be repaired immediately to protect the residents from potential injury and to protect the Association from potential liability. We have identified safety hazards in the *List of Recommended Repairs* by printing them in **bold**. We do NOT warranty that all defects throughout the community that could be considered “safety defects” are identified in the *List of Recommended Repairs*.

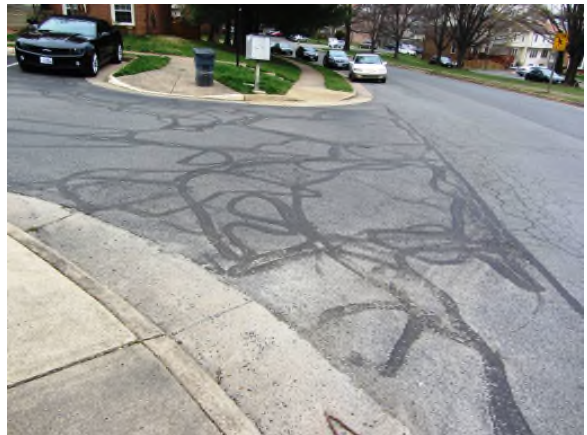
Pavement defects include open cracks, holes and alligating. Depressed pavement and areas with ponding water likely indicate damage to the base materials and bearing soils beneath the pavement.

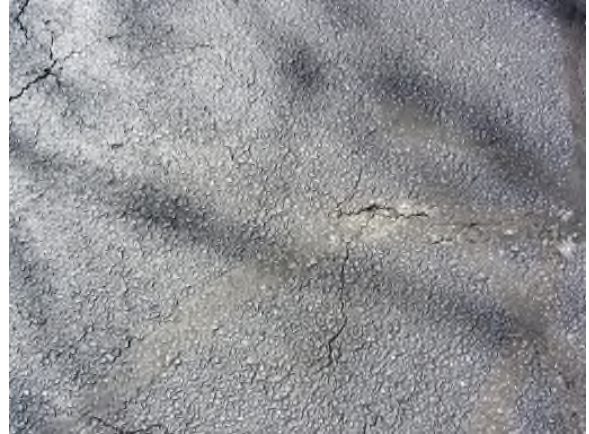
Areas of asphalt pavement with more serious defects or where base materials and/or bearing soils beneath the pavement are damaged, will need to be removed and replaced with materials capable of properly supporting the new pavement. If the defects are not corrected before the installation of the new asphalt pavement, the new pavement frequently begins failing almost immediately and will generally be at complete failure in three to five years. The replacement cost shown in the *Replacement Reserve Inventory* assumes a normal replacement project with defects needing to be addressed at five to 10 percent of the total area.

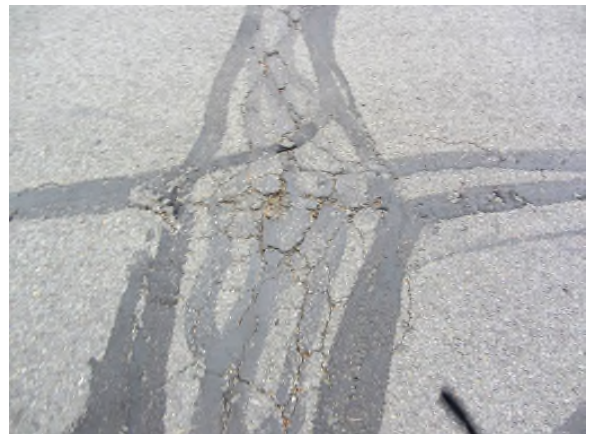
REPLACEMENT RESERVE REPORT

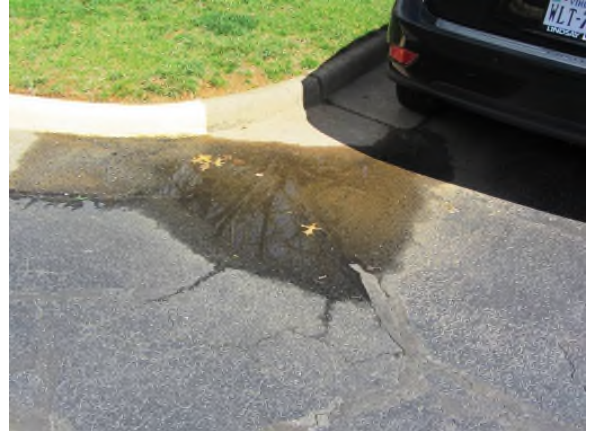
HL Asphalt - Asphalt Replacement - associated work - utilities. Utility installations under and in the general vicinity of the asphalt pavement scheduled for replacement should be evaluated. Pending or near future projects should be accomplished prior to asphalt replacement and when this is not possible, the installation of conduit and/or pipe under the pavement to allow for future installations should be evaluated.

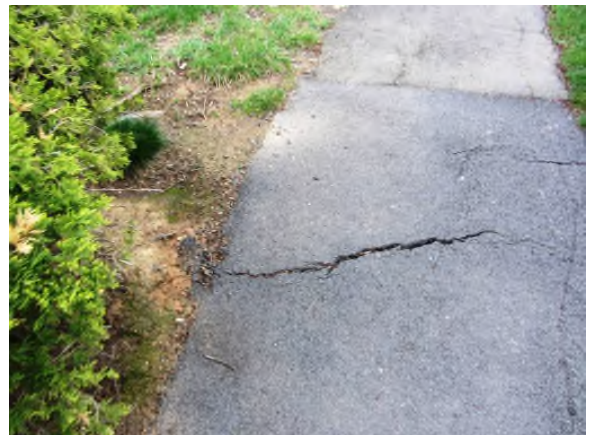
LL Asphalt trail - replace. The costs shown in the *Replacement Reserve Inventory* assume the Association will conduct a Trail Replacement Project (Trail Replacement) at 20 percent of the trails every four years. Trails do not have to support heavy loads. Water penetration into the base materials and bearing soils causes rapid and accelerated deterioration when it is combined with the heavy loads created by cars and trucks. Because the trails are not exposed to the heavy loads, water penetration is not a major concern in trails. Below is a list of the asphalt trail defects assumed to require corrective actions:

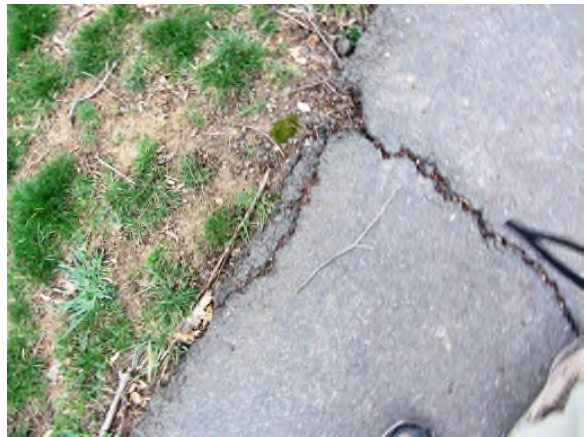
- Defective grading. Defective grading adjacent to the pavement can impound water, silt, and debris, creating a trip hazard. Long term, even without the load of vehicles, water ponded on the pavement will cause excessive edge raveling, requiring replacement. Corrective actions may require the installation of culverts.

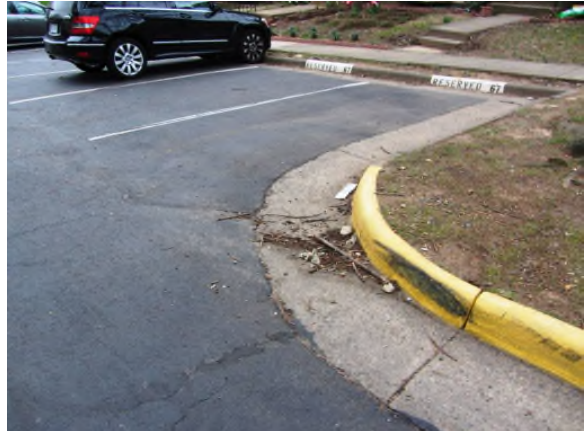
We have assumed that 4 percent of the concrete components will be replaced in conjunction with the asphalt pavement replacement project scheduled in 2018. Subsequent cycles of concrete component replacements are scheduled at 4 year intervals in the *Replacement Reserve Inventory*, to coincide with future asphalt replacement and interim cycle projects.

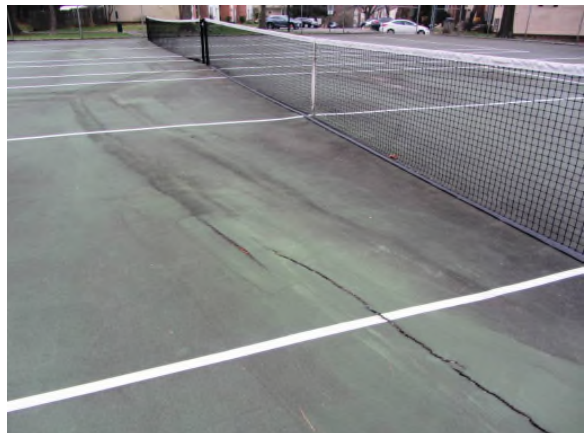
REPLACEMENT RESERVE REPORT

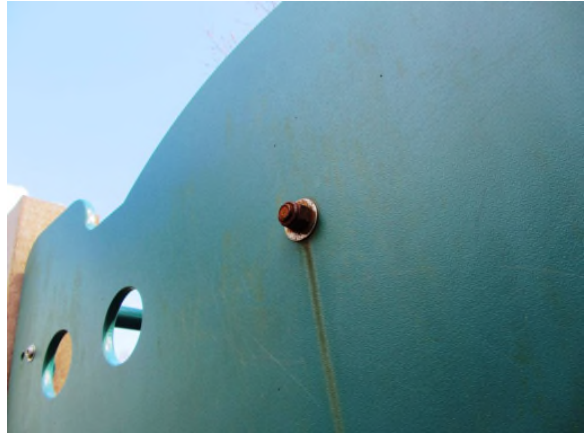
Site grading. We observed a large number of site grading problems throughout the community and multiple locations where corrective actions have been attempted but have failed. Because of the scope of the problem, we have included a line item in the Replacement Reserve Inventory for a site grading study. This study should be conducted by a Licenced Professional Engineer or Landscape Architect with experience in resolving difficult site grading problems.

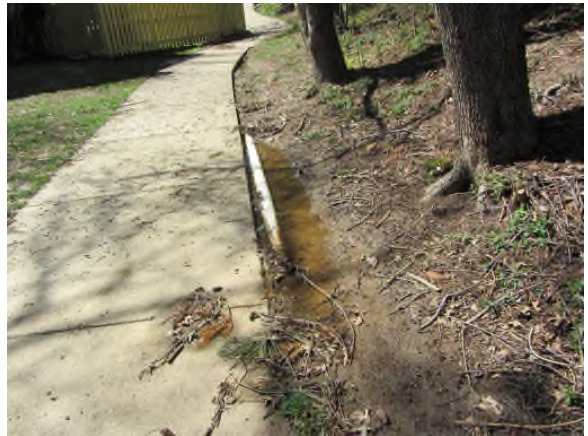
We have estimated that the corrective actions identified by this study will cost \$400 per unit but we will modify the study (at no cost to the Association) to reflect the final findings of the study.

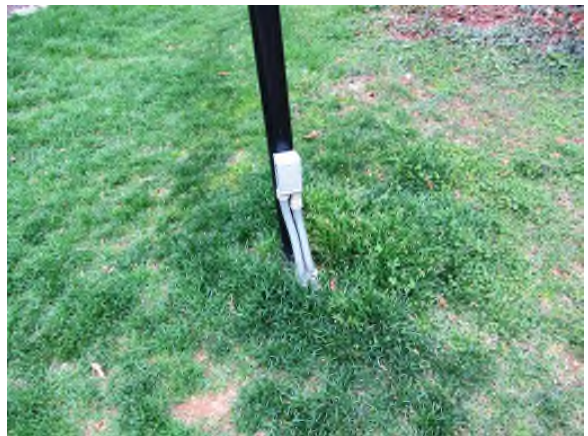
In the Replacement Reserve Inventory, we have assumed that the varying ages and condition of the equipment will allow for phased replacement but will modify the study (at no cost to the Association) to reflect the final findings of the study.

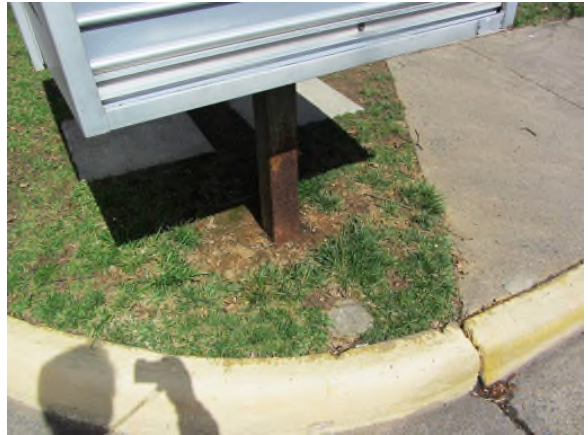
REPLACEMENT RESERVE REPORT

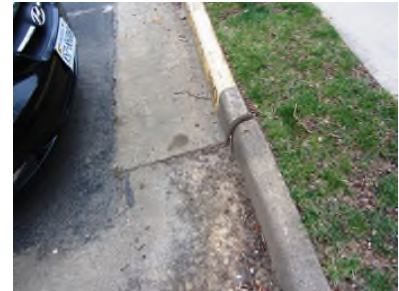
The percentage of the components scheduled for replacement should be adjusted in future years based on historical data and experience. All other components are included in the *Replacement Reserve Inventory* at their full estimated replacement cost.

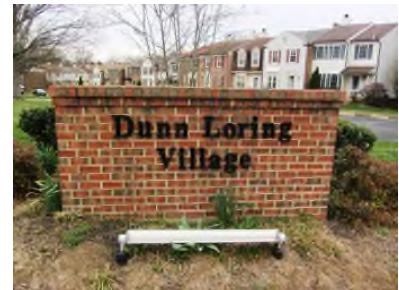
REPLACEMENT RESERVE REPORT

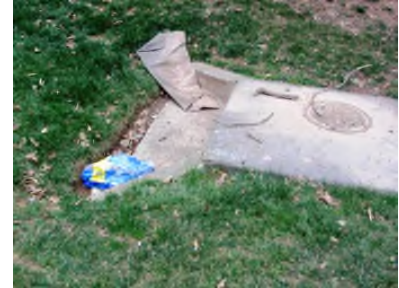
- Domestic water supply mains and sanitary sewers. A network of domestic water mains and sanitary sewers is installed throughout the community on property owned by the Association. No drawings detailing the components of the system were available for our review. We have assumed that any needed repairs/replacements of the components of this system will not be funded from Replacement Reserves.

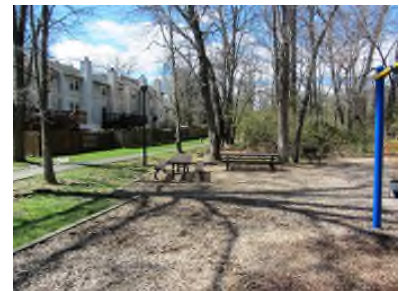
Unit improvements. We understand that the elements of the project that relate to a single unit are the responsibility of that unit owner. Examples of components excluded from the *Replacement Reserve Inventory* by this standard include:

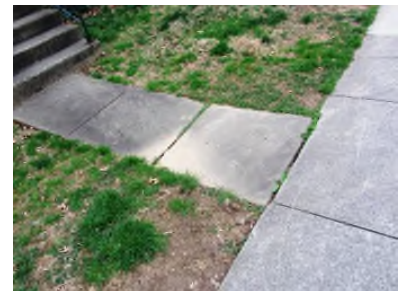
REPLACEMENT RESERVE REPORT

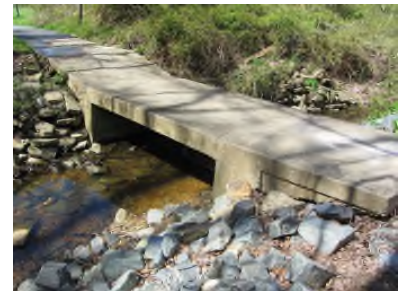
Government. Site improvements that serve the community are located on property owned by the local or state government. These improvements are located in the following areas:

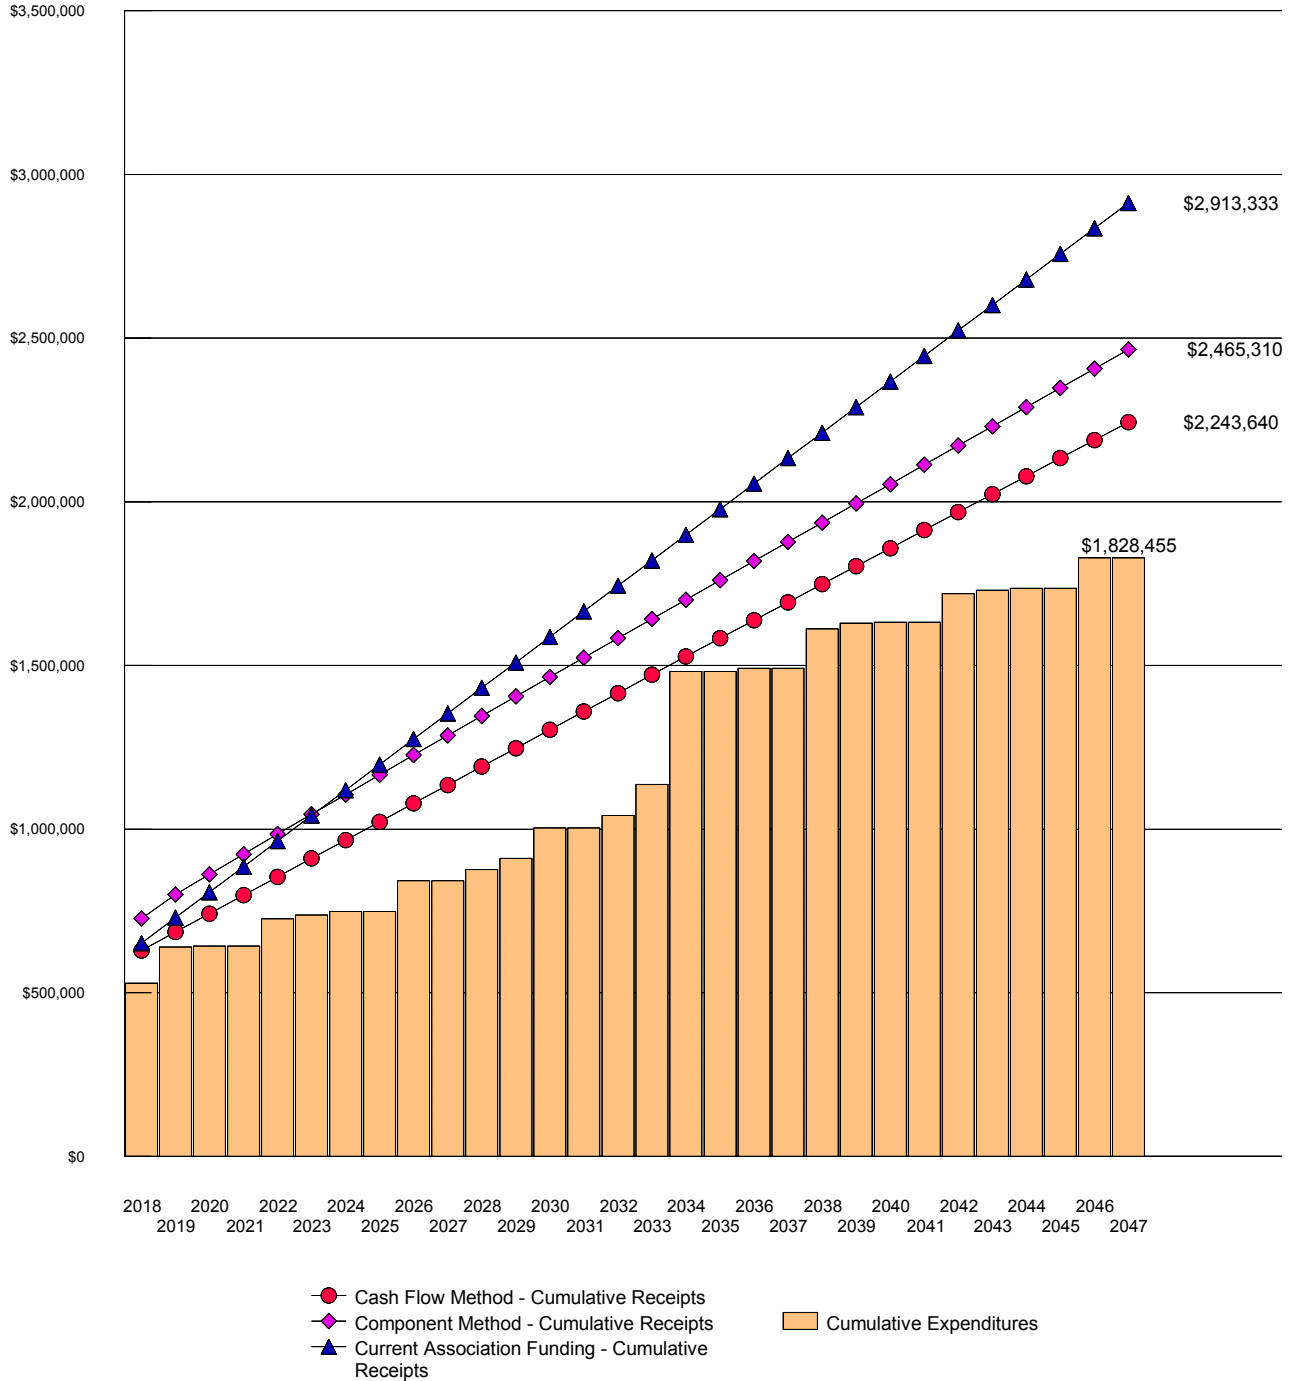
REPLACEMENT RESERVE ANALYSIS

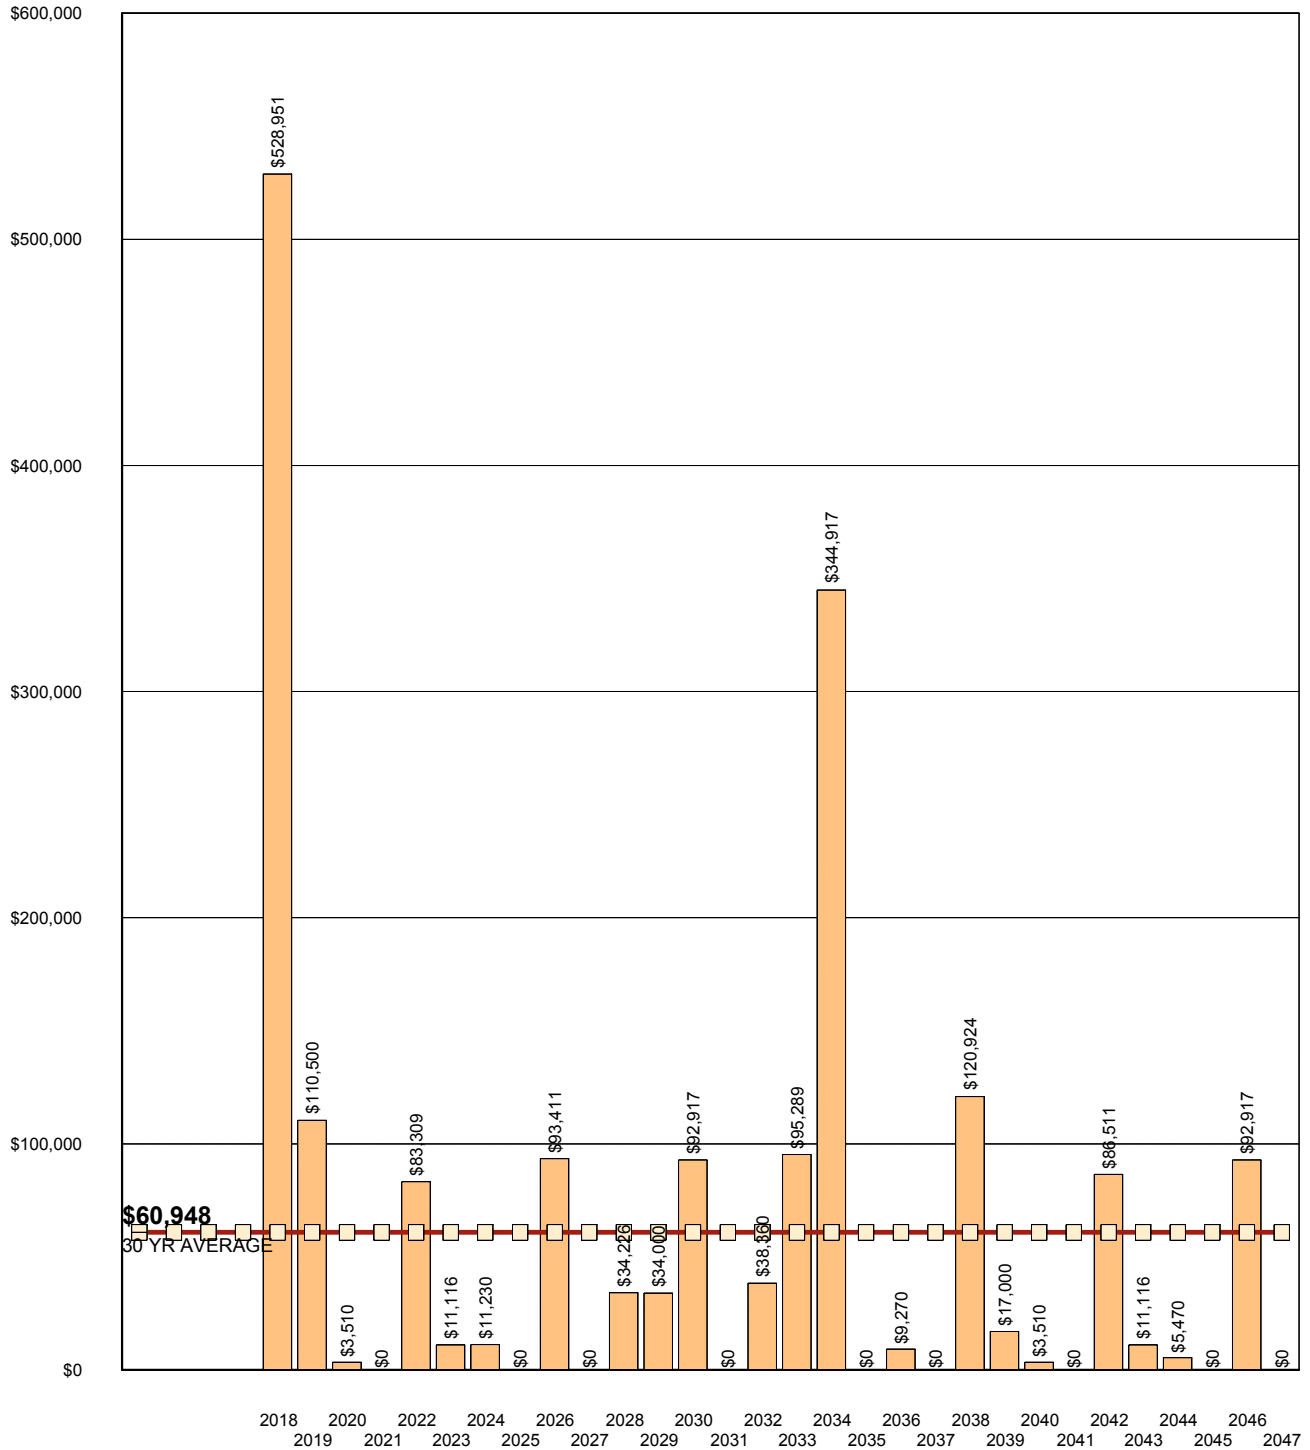
Richard J. Schuetz, AIA, Architect

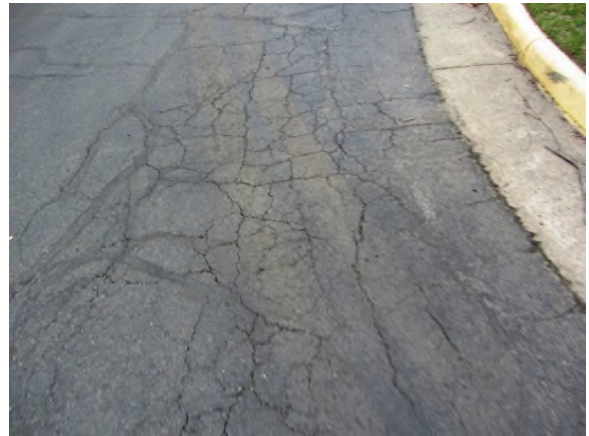
- **Overlay.** Replace the existing asphalt pavement by overlaying with 2 inches of new asphalt. Prior to the installation of the new pavement, mill the existing asphalt pavement to insure that the final grade of the new pavement will not impound water and to eliminate the need to run raise the elevation of the pavement at the curbs and sidewalks.

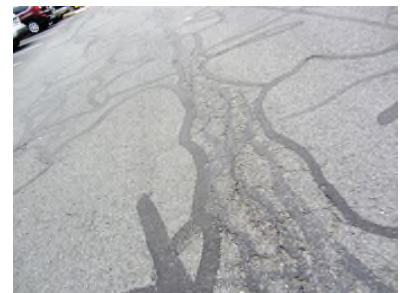
- **Evaluate and specify.** Identify the asphalt pavement that can be overlaid without repair. Evaluate asphalt pavement that will require repair if the new asphalt pavement will have a normal economic life. Specify the scope of the necessary corrective actions.
- **Minor defects.** Correct minor defects in the asphalt pavement that are limited to the asphalt pavement (no damage to the base materials or bearing soils), to insure that the new asphalt pavement will have a normal economic life.

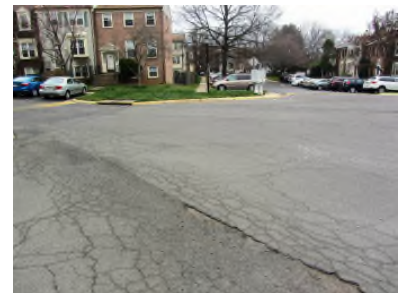
LIST OF RECOMMENDED REPAIRS

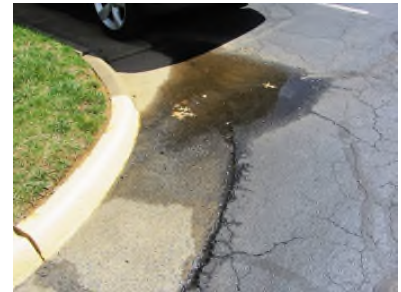
2. Asphalt trails - replace and restore (light load "LL")

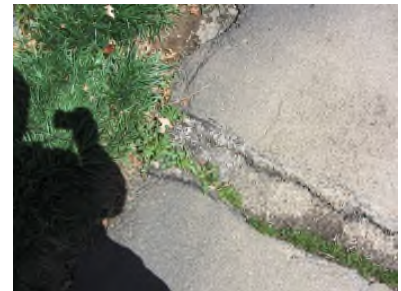
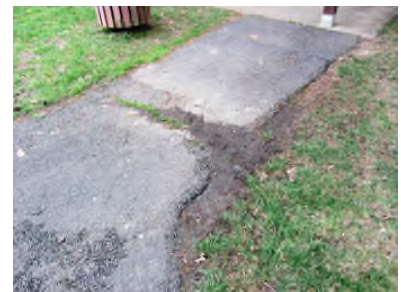
LIST OF RECOMMENDED REPAIRS

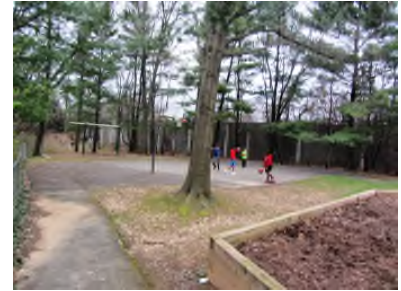
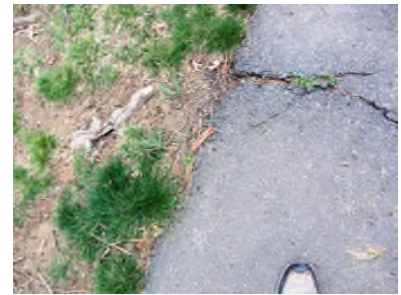
- **Asphalt trails (LL) - restore (crack seal & sealcoat).** A properly specified and executed replacement/repair project as outlined above should be successful in allowing the asphalt trails to achieve an economic life significantly longer than roadways and parking areas. To address the cosmetic consequences of keeping the asphalt trails in service over an extended period of time, we have included a project to sealcoat and crack seal the pavement every four years, in conjunction with the replacement/repair project outlined above and that it will address the 85 percent of the pavement not included in the replacement project. See Supplemental Photographs #.

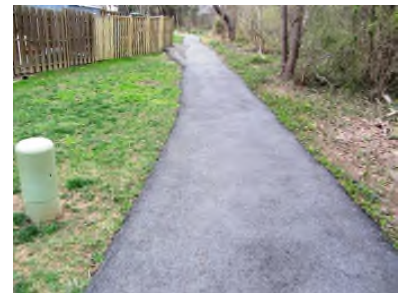
3. Asphalt pavement (HL) & asphalt trails (LL)

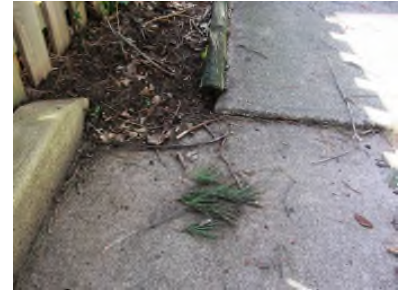
- Concrete curb & gutter. Replace defective concrete curb & gutter segments. The curb & gutter segments that require replacement have one or more of the defects outlined below. See Supplemental Photographs #3, 27, 32, 33, 48, 65.

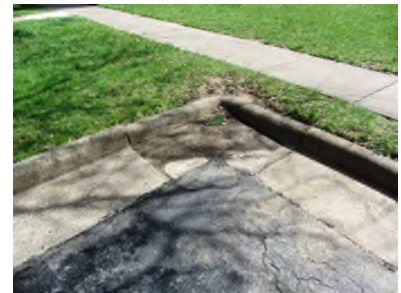
5. Grading, drainage, and landscape.

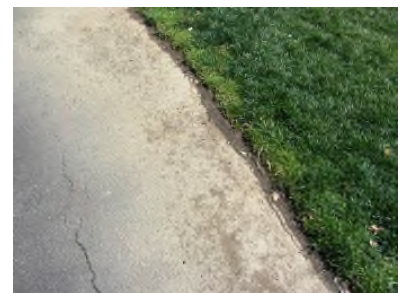
LIST OF RECOMMENDED REPAIRS

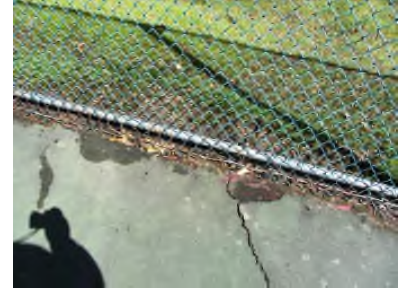
- **Grade between sidewalks and curbs.** Grade between sidewalks and curbs to prevent water being impounded in these areas and the consequential deterioration of adjacent components. See Supplemental Photographs #5.

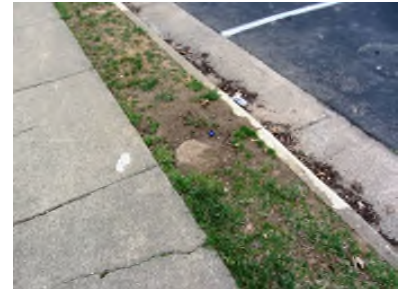
- **Grade behind buildings.** Establish proper grade behind the rear fences of all units to move water to a component of the stormwater system. See Supplemental Photographs #6, 75.

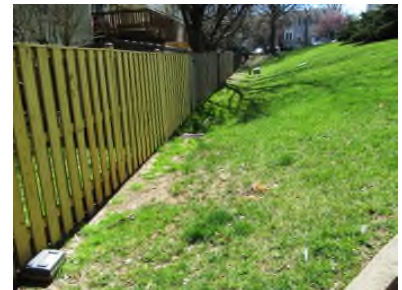
- **Erosion and ground cover.** Correction erosion damage and establish proper ground cover on property owned by the Association. See Supplemental Photographs #18, 24, 34, 82.

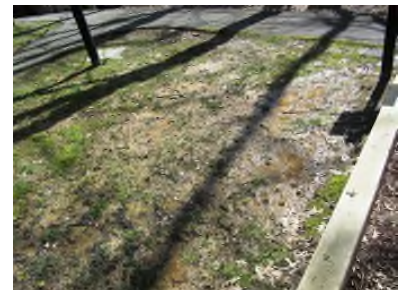
LIST OF RECOMMENDED REPAIRS

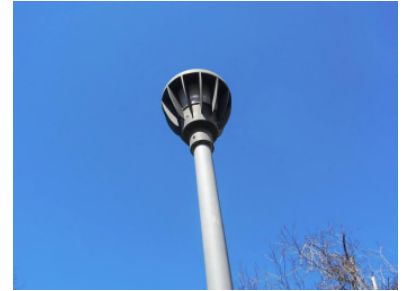
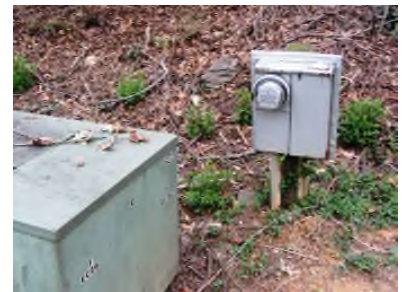
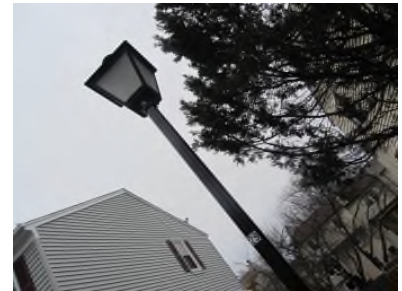
- **Evaluation.** Conduct an engineering study to evaluate the existing site lighting system and to identify appropriate replacement methodologies and equipment. The elements to be evaluated include but are not limited to those outlined below. See Supplemental Photographs #28, 58.
 - Cost of operations - existing and possible replacement systems.
 - Condition of existing electrical services and their possible integration into a new and much less power demanding system.
 - Condition of existing underground wiring including the extent of wire replacement project that have been conducted in the past.
 - Condition of existing posts and fixtures.
 - Lighting requirements for a new lighting system including regulatory compliance and resident needs.
- **Replacement.** Make replacements as identified by the engineering study.

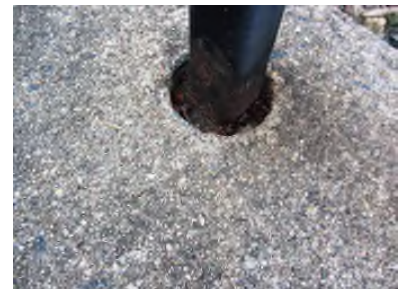
LIST OF RECOMMENDED REPAIRS

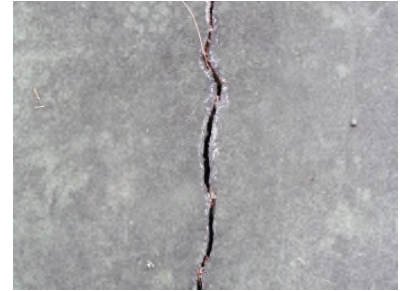
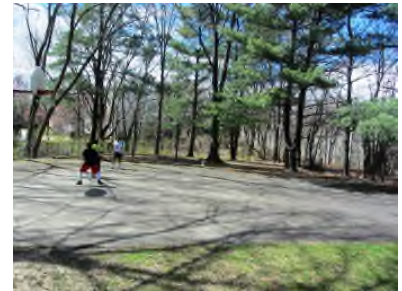
- **Restore tennis courts.** Replace base asphalt and color coat at the tennis courts. The work should be done in conjunction with the correction of defective grading adjacent to the courts as outlined above. See Supplemental Photographs #12, 76, 77, 78.
- **Restore multipurpose court.** Replace base asphalt at the multipurpose courts. The work should be done in conjunction with the correction of defective grading adjacent to the court as outlined above. See Supplemental Photographs #19, 20, 21

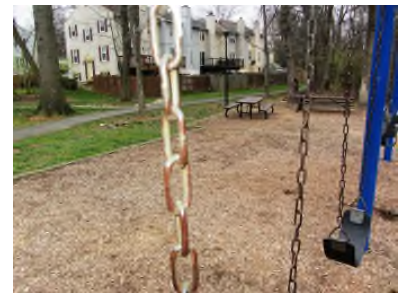
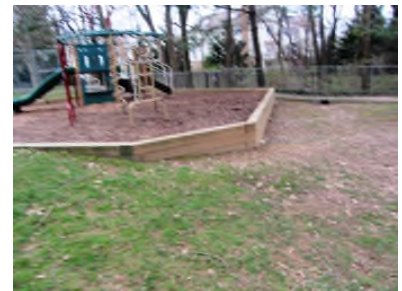
LIST OF RECOMMENDED REPAIRS

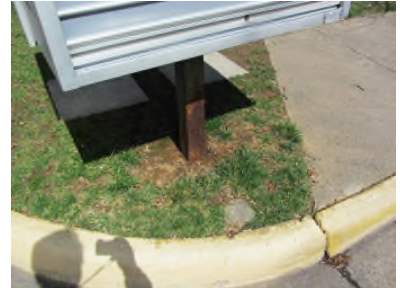
11. Site Improvements - Miscellaneous

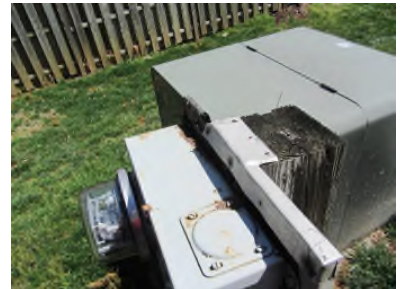
- **Electric at entrance feature.** Correct defective outlet at entrance feature. See Supplemental Photographs #2.

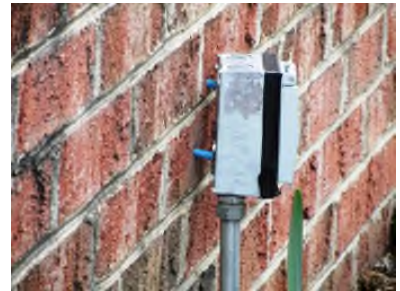
- **Signage.** Restore/replace deteriorated signs throughout the community. See Supplemental Photographs #3, 49.

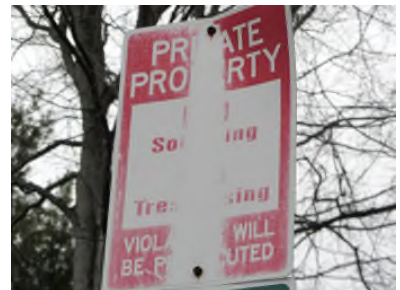
LIST OF RECOMMENDED REPAIRS

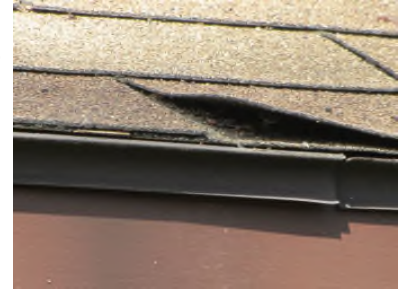
- **Correct minor defects in the shelter roof.** Seal lifted shingles in the shelter roof. See Supplemental Photographs #79, 80.

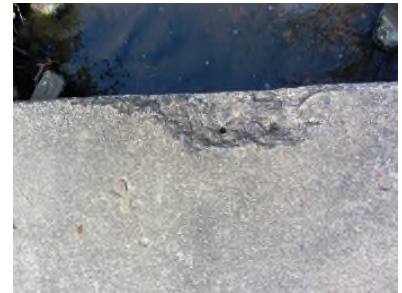
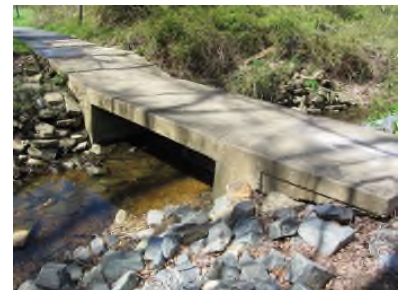
TOTAL COST OF RECOMMENDED REPAIRS

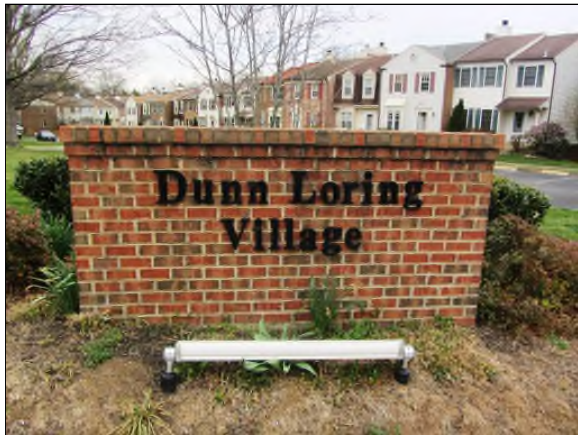
Photo #1. Entrance feature at the corner of Grovemore and Hilltop

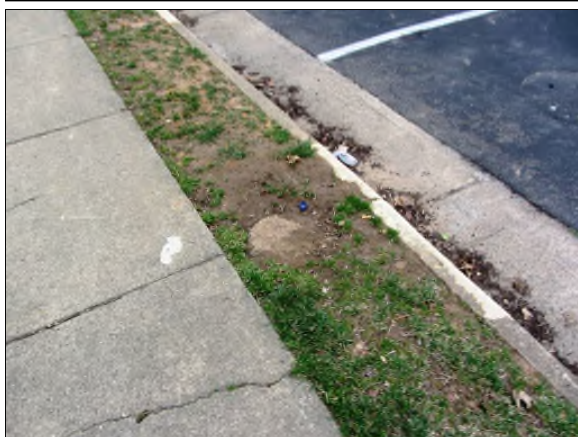
Photo #5. Defective grading and utility access point at incorrect height, Grovemore west section.

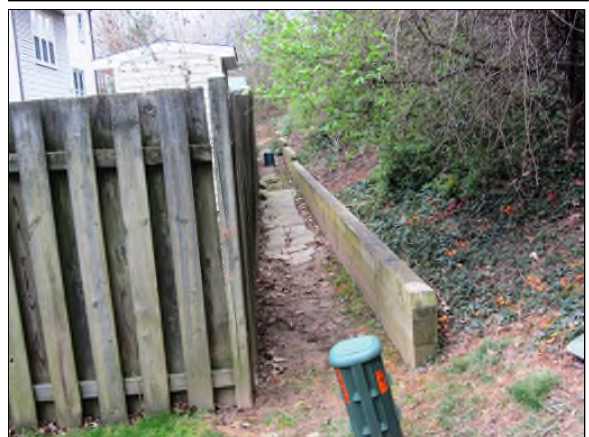
Photo #6. Retaining wall located behind several of the Grovemore west section units.

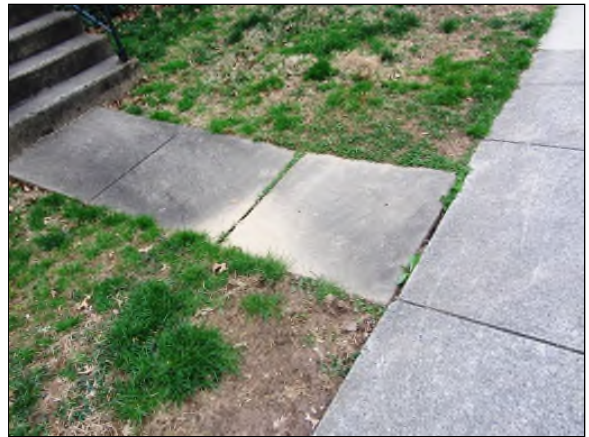
Photo #10. Defective lead walks are assumed to be unit owner responsibility.

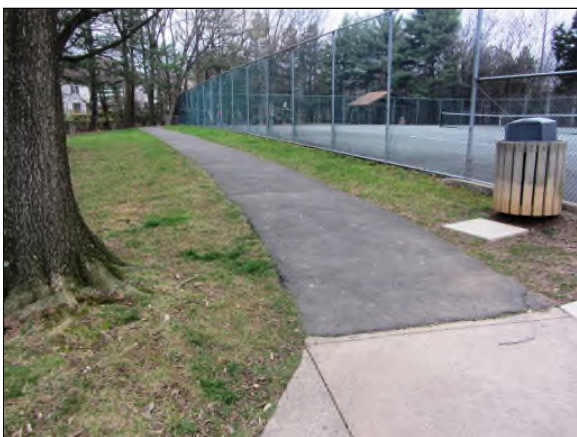
Photo #11. Asphalt trail at tennis court.

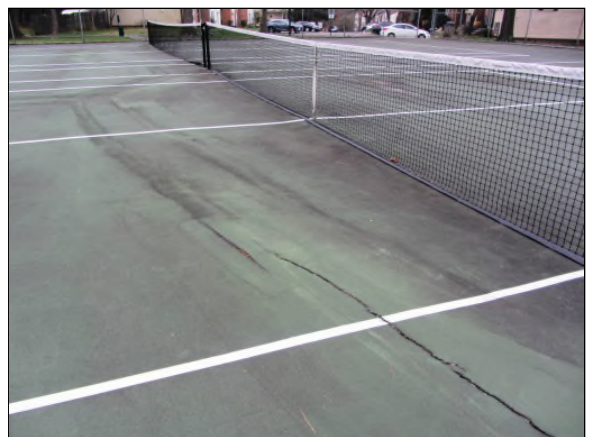
Photo #12. Tennis court with large open cracks.

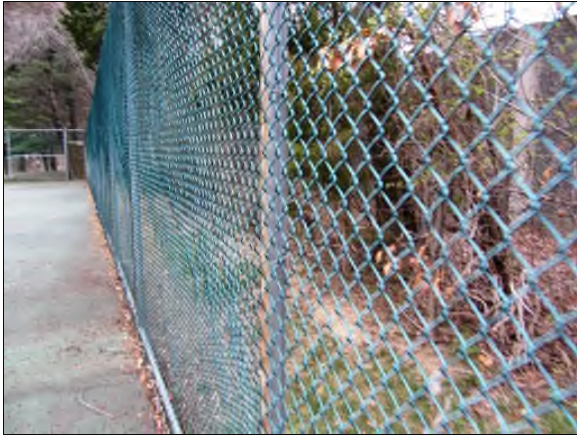
Photo #13. Tennis court fence.

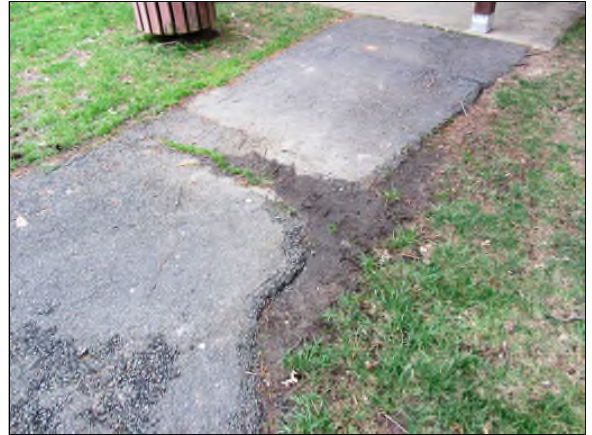
Photo #14. Defective grading adjacent to asphalt trail.

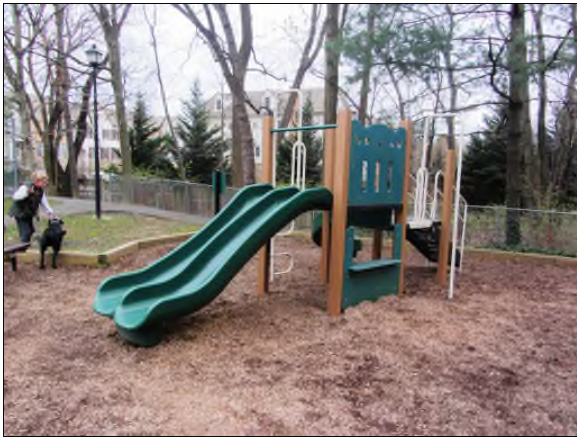
Photo #15. West tot lot multipurpose equipment.

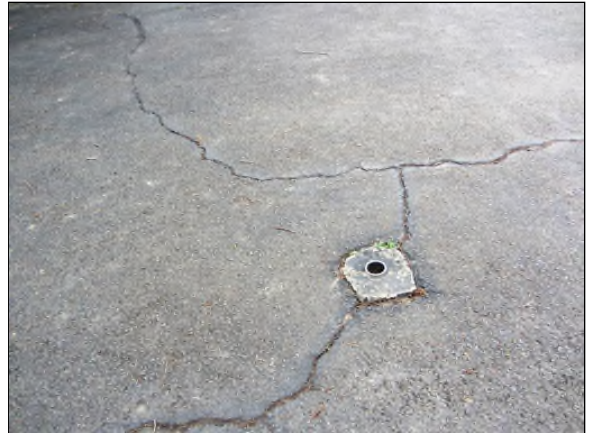
Photo #20. Typical defects in multipurpose court.

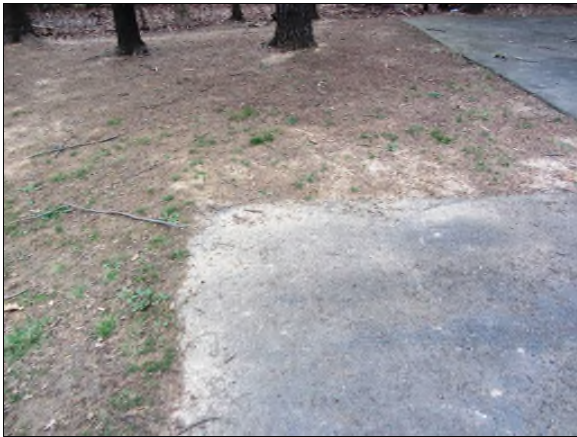
Photo #21. Defective grading adjacent to multipurpose court.

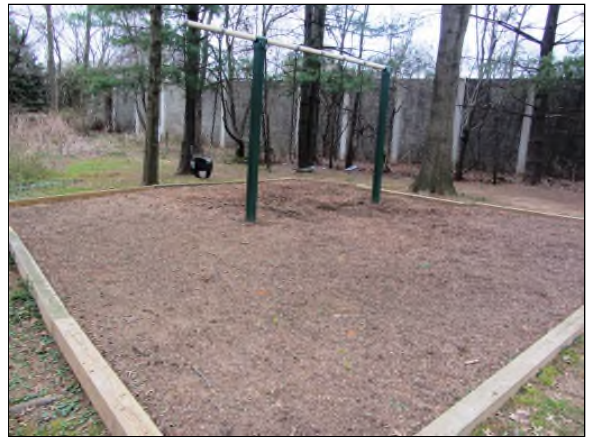
Photo #22. West swing.

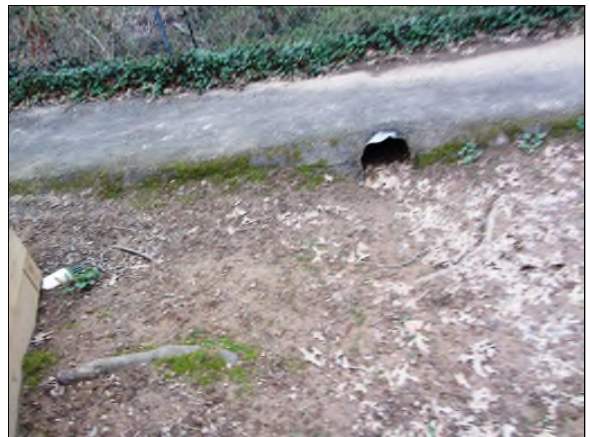
Photo #24. Lack of ground cover and inadequate pavement thickness above culvert.

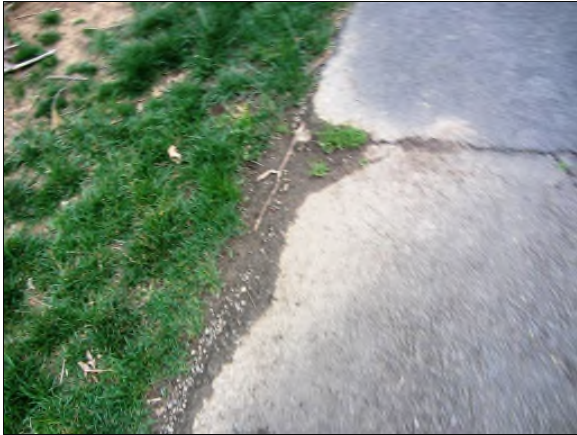
Photo #25. Defective grading adjacent to asphalt trail.

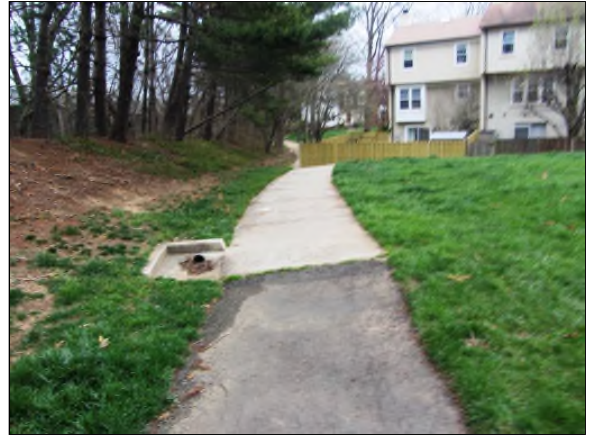
Photo #26. Intersection of asphalt and concrete trails adjacent to the north property boundary

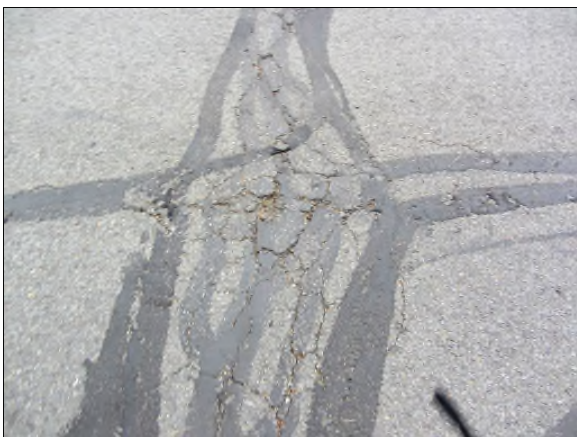
Photo #29. Typical cracked and alligatored asphalt pavement with ineffective crack sealing.

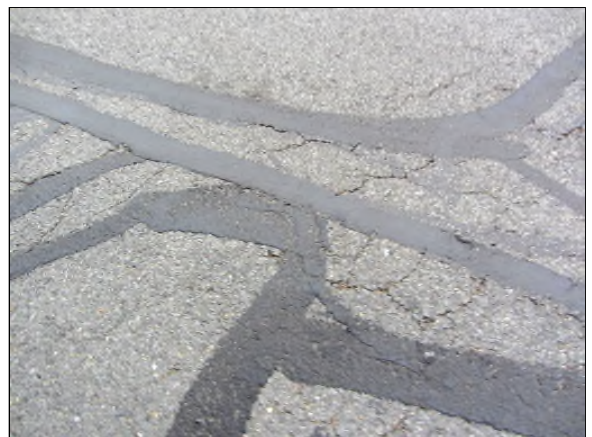
Photo #30. Typical cracked and alligatored asphalt pavement with ineffective crack sealing.

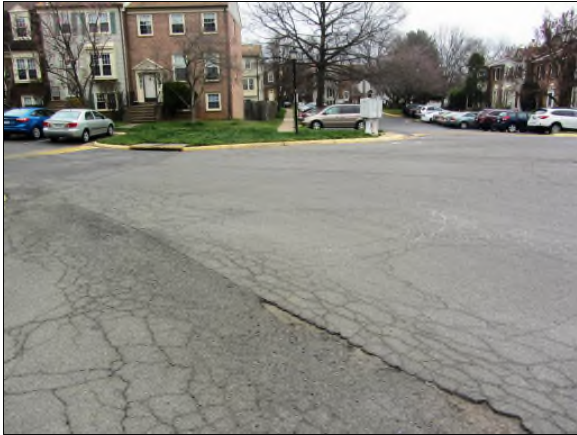
Photo #31. Typical cracked and alligatored asphalt pavement with ineffective crack sealing.

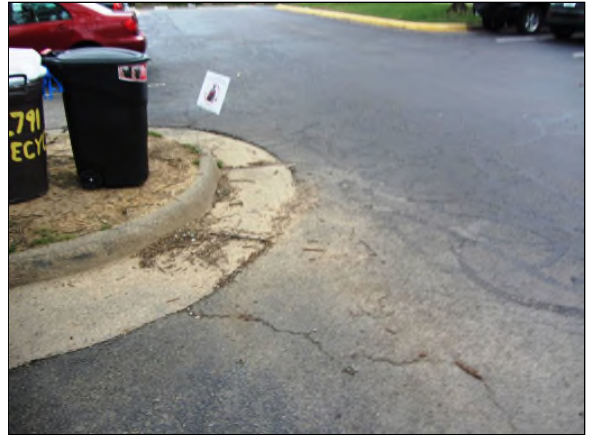
Photo #32. Depressed asphalt pavement and concrete curb & gutter impounds water and likely indicates damage to base materials and bearing soils below.

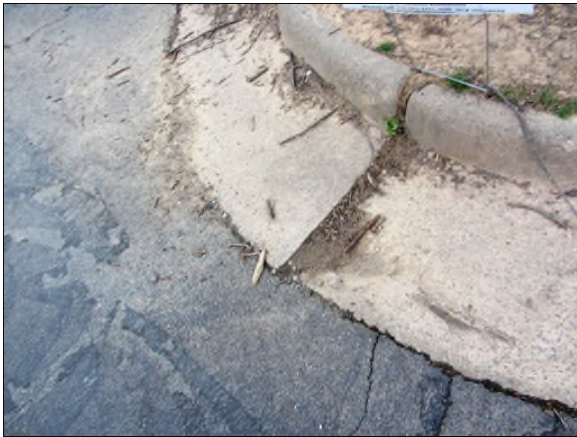
Photo #33. Typical displaced concrete curb & gutter.

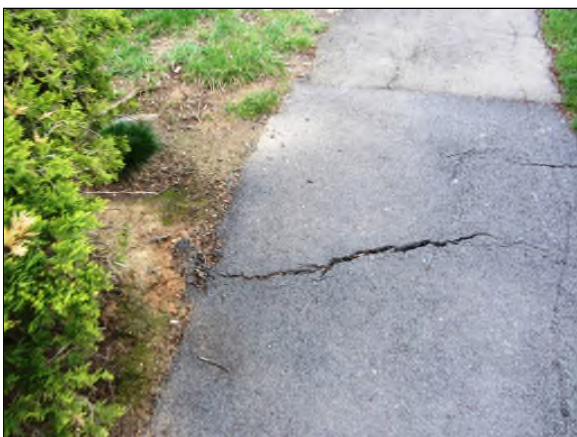
Photo #35. Typical damaged asphalt trail.

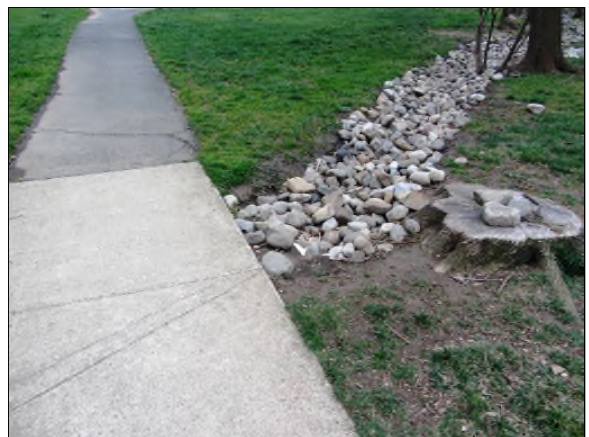
Photo #36. Rock lined drainage swale near the east tot lot.

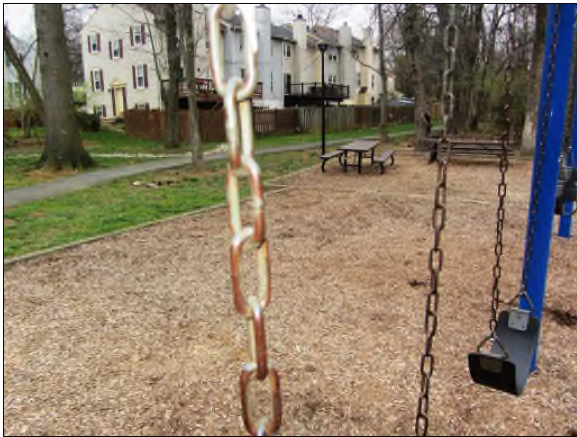
Photo #39. Deteriorated chain, swing in east tot lot.

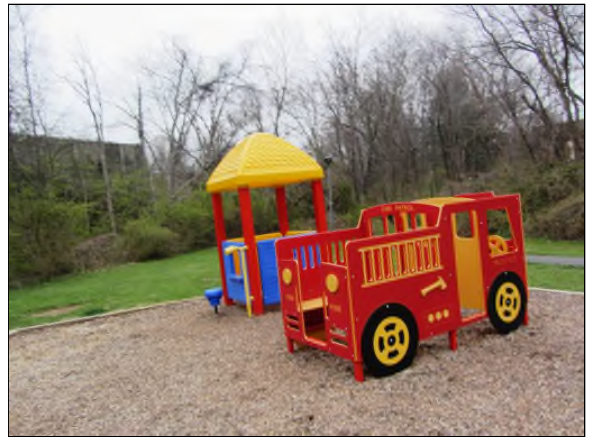
Photo #40. Static tot toys, east tot lot

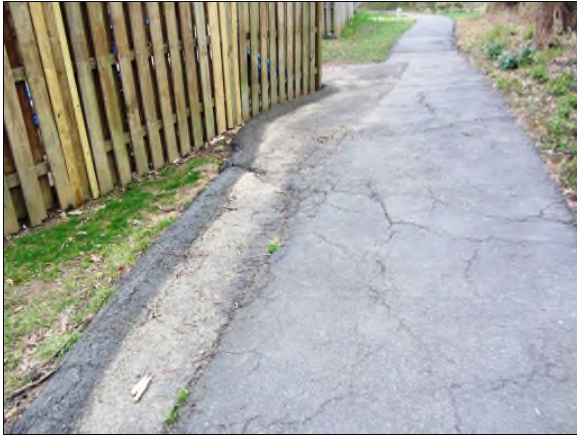
Photo #43. Typical deteriorated asphalt trail.

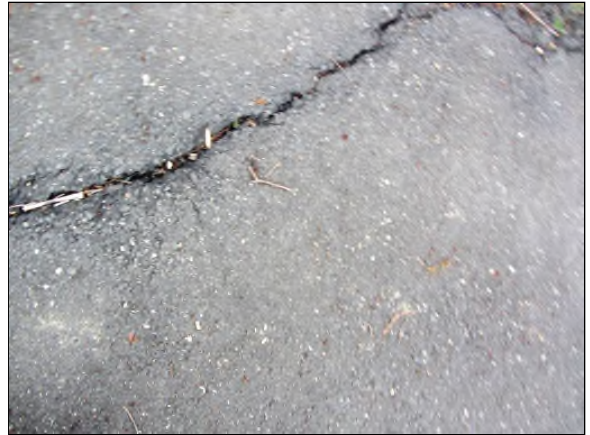
Photo #44. Open crack in asphalt trail.

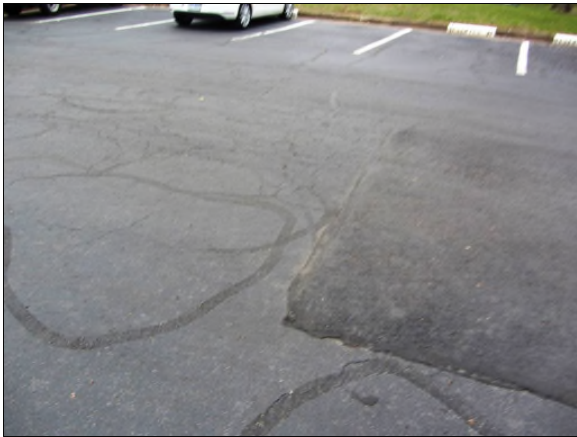
Photo #45. Typical alligatored asphalt pavement and large patches.

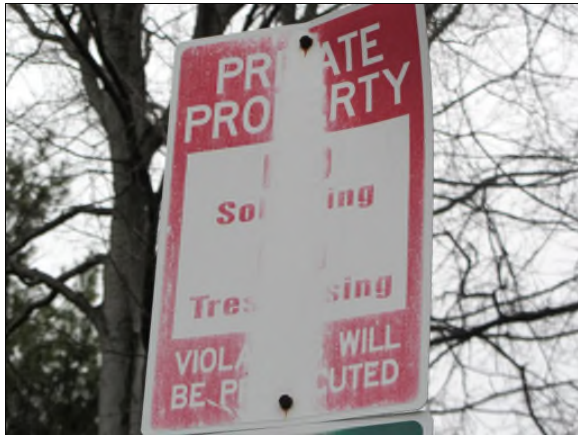
Photo #49. Failed signage.

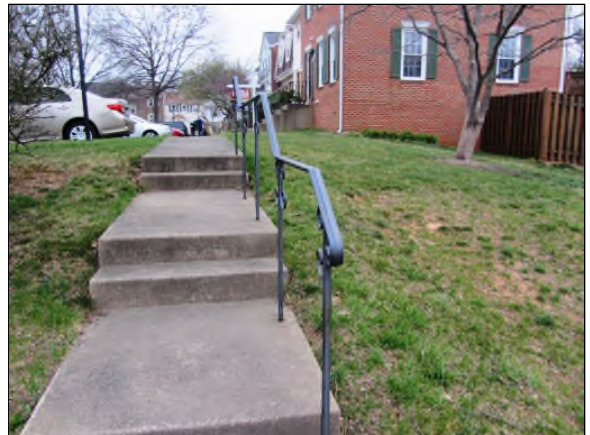
Photo #50. Metal handrails.

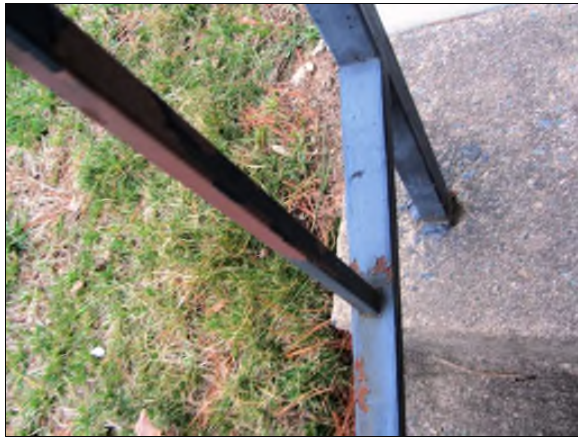
Photo #51. Failed paint system on the metal handrails.

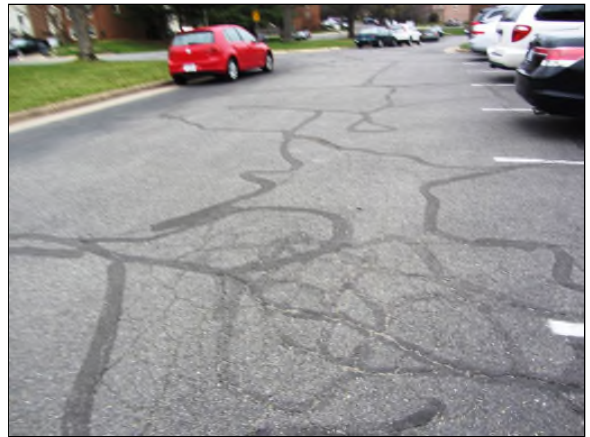
Photo #52. Alligatoring asphalt pavement.
