Replacement Reserve Study
DUNN LORING VILLAGE

RSTUDY+
REPLACEMENT RESERVE STUDY

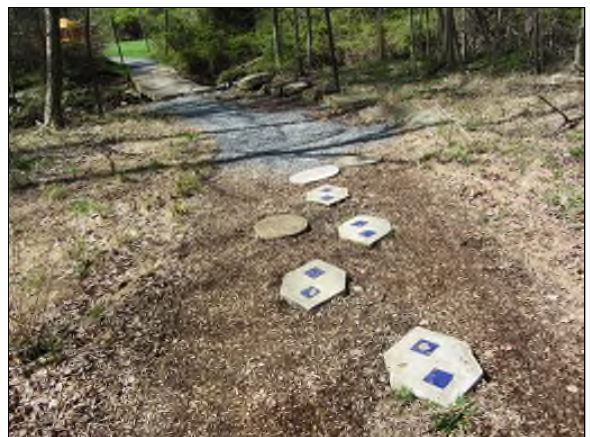
Photo #54. Unsafe walkway leads to the east side of bridge.

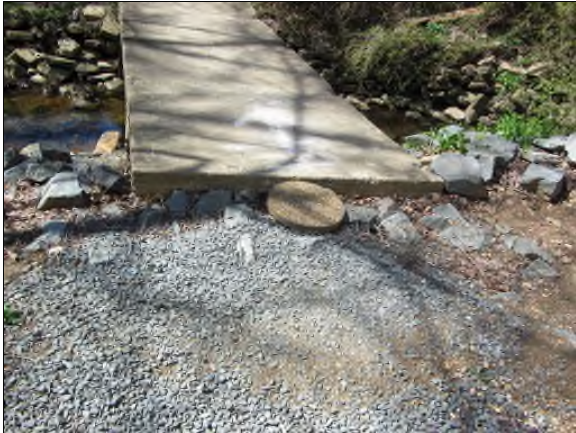
Photo #55. Erosion at east side of bridge.

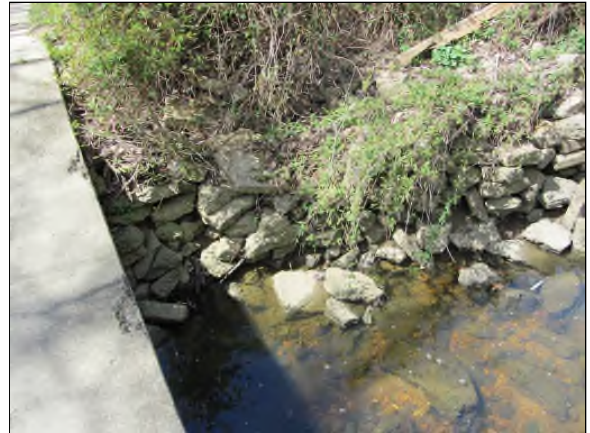
Photo #56. Damaged edge of concrete are likely a where safety railings were once attached.

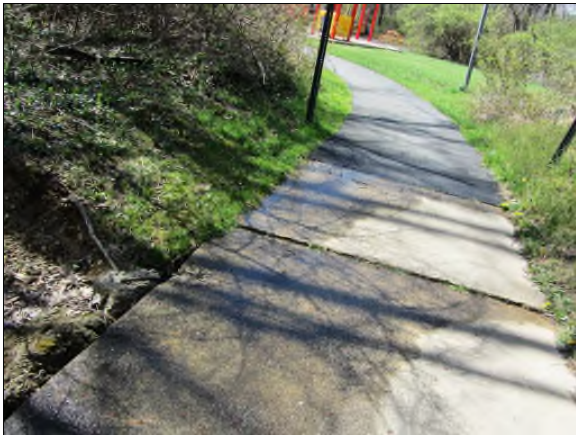
Photo #57. Displaced concrete pavement on the west side of bridge and defective grading adjacent to the pavement create a potential trip hazard.

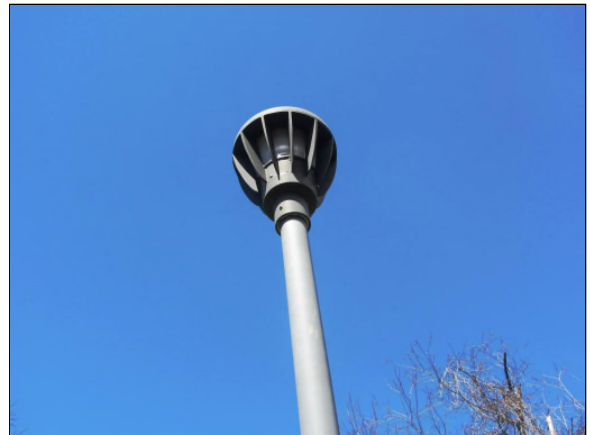
Photo #58. Post light near the east tot lot.

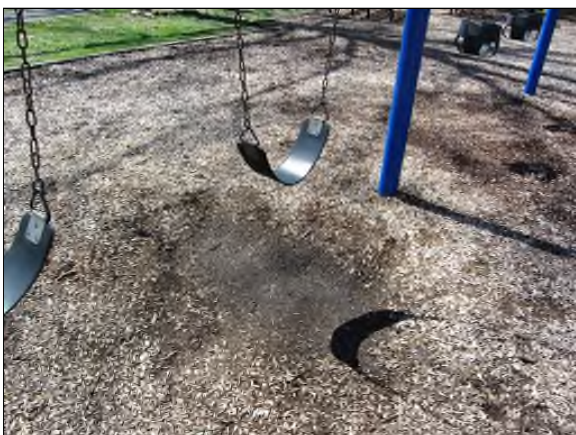
Photo #59. Inadequate resilient surfacing in the east tot lot.

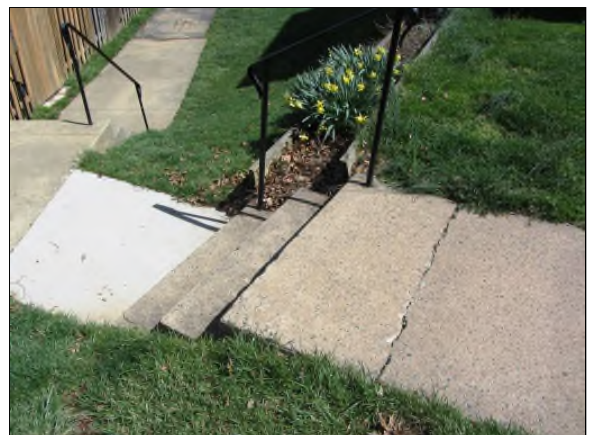
Photo #60. Handrails installed along exterior concrete stairs. Note crack immediately above the stair.

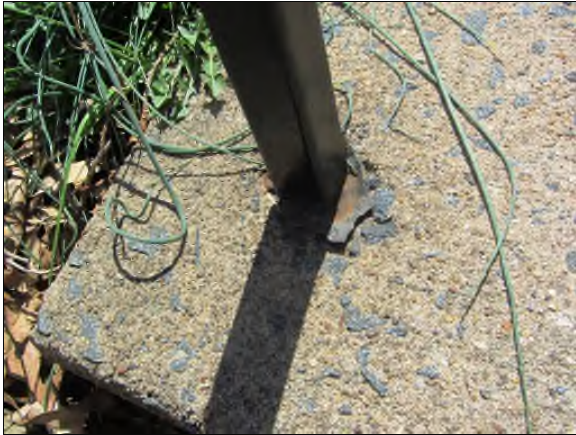
Photo #61. Defective railing socket impounds water causing accelerated deterioration of the metal railing.

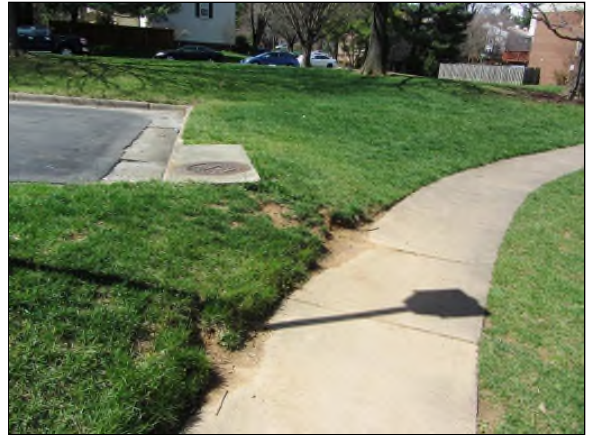
Photo #62. Defective grading adjacent to concrete sidewalk.

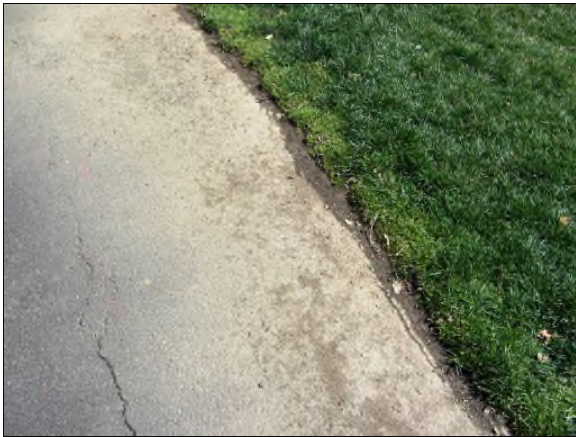
Photo #63. Defective grading adjacent to asphalt trail.

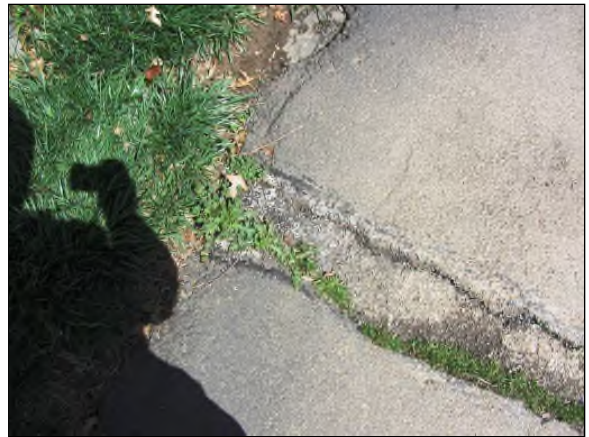
Photo #64. Poorly executed repair to asphalt trail is a potential trip hazard.

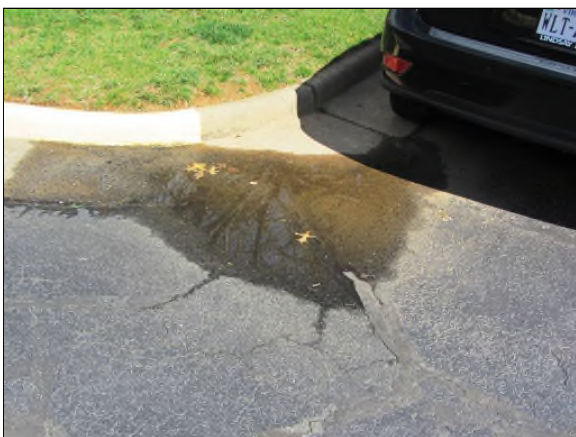
Photo #65. Depressed asphalt pavement and concrete curb & gutter impounds water and likely indicates damage to base materials and bearing soils below.

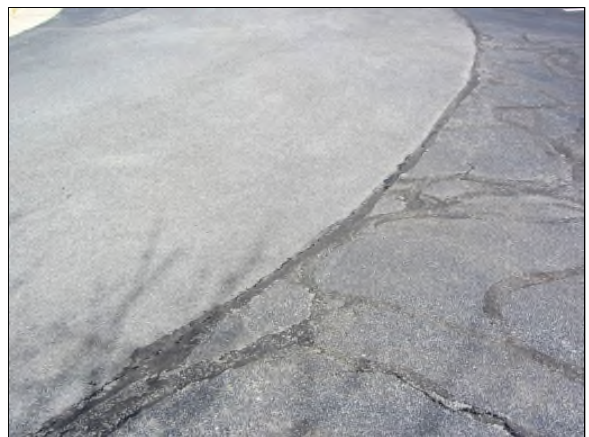
Photo #66. Alligatored asphalt pavement adjacent to a patch will result in the patch having a reduced economic life.

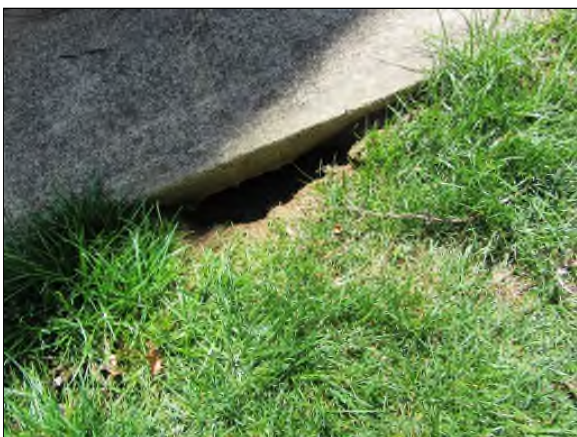
Photo #71. Defective grading directs water under the concrete pavement where it will cause accelerated deterioration.

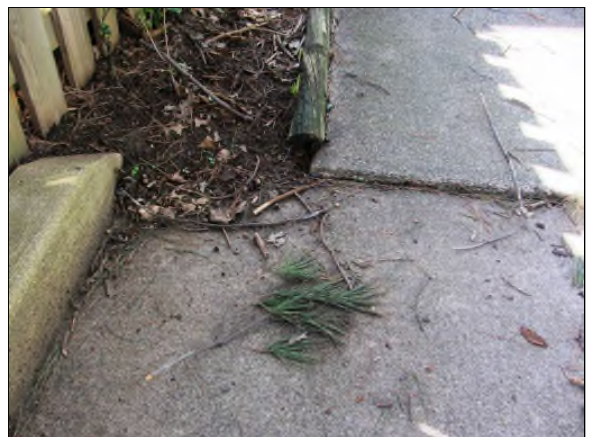
Photo #72. Typical displaced concrete pavement.

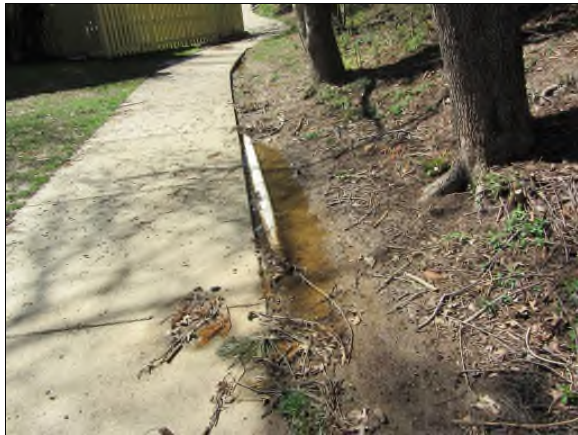
Photo #73. Defective grading (and apparent drainage project) adjacent to concrete pavement.

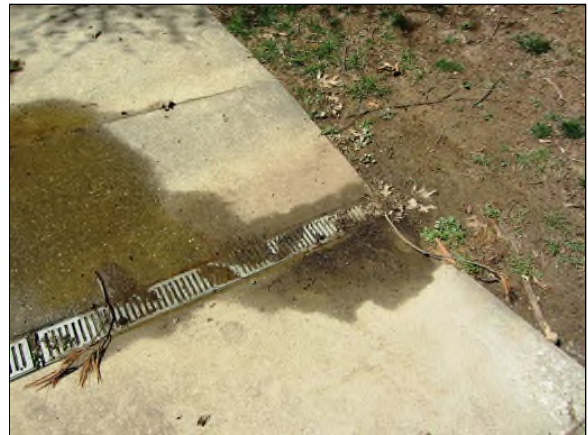
Photo #74. Defective grading (and apparent drainage project) adjacent to concrete pavement.

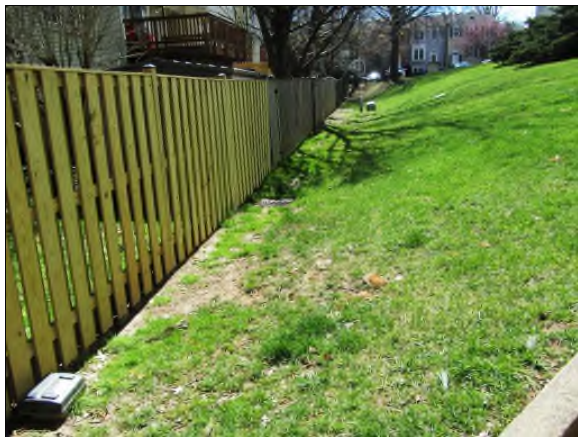
Photo #75. Typical open space behind units that has not been properly graded to move water to the stormwater system.

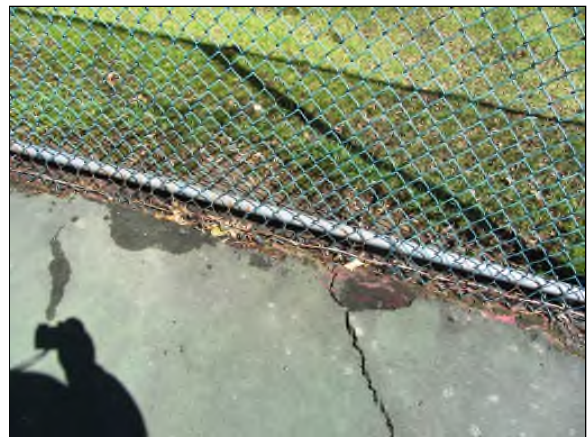
Photo #76. Defective grading at tennis court damages the base materials and bearing soils and causes accelerated deterioration.

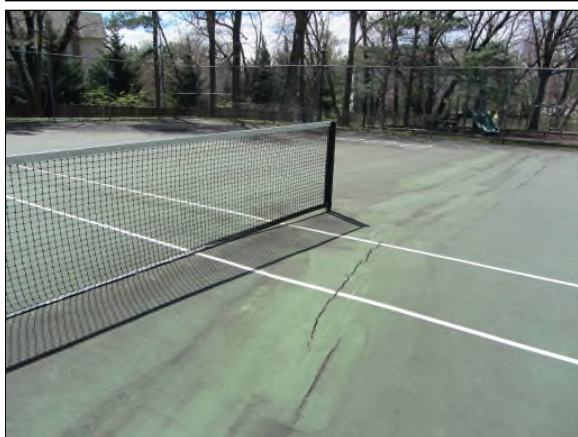
Photo #77. Patching of failed tennis court base asphalt is expensive and ineffective at extending the life of the court.

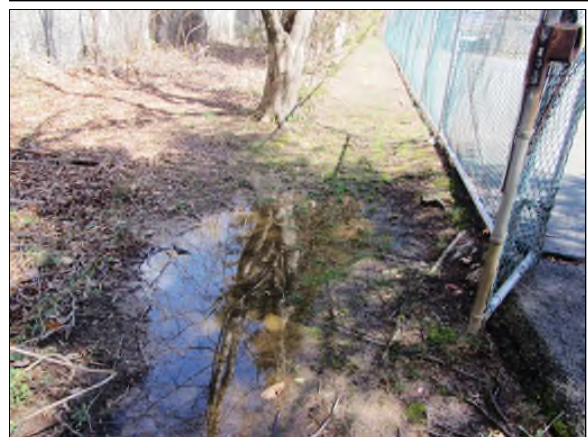
Photo #78. Defective grading at tennis court damages the base materials and bearing soils and causes accelerated deterioration.

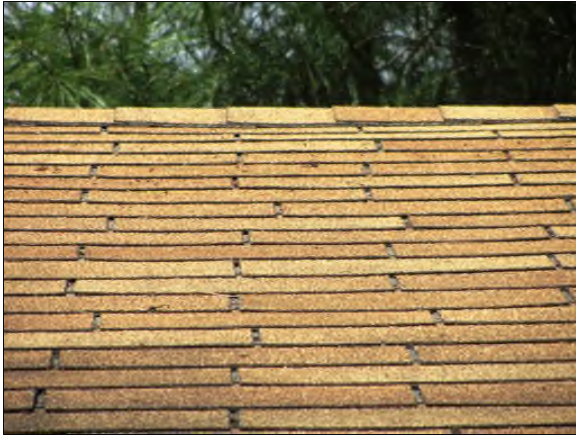
Photo #79. Asphalt shingles on shelter near the tennis courts are not properly aligned/installed.

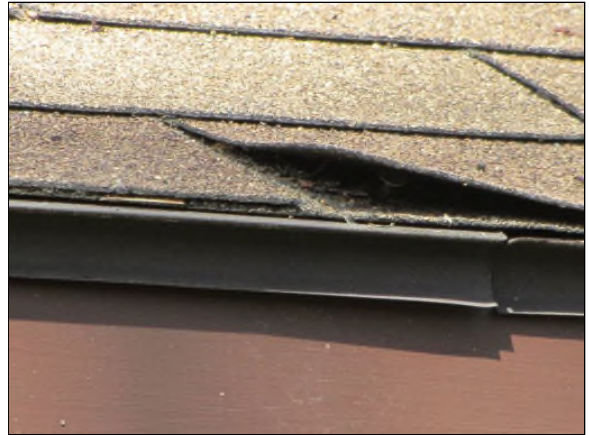
Photo #80. Lifted shingles are prone to wind damage.

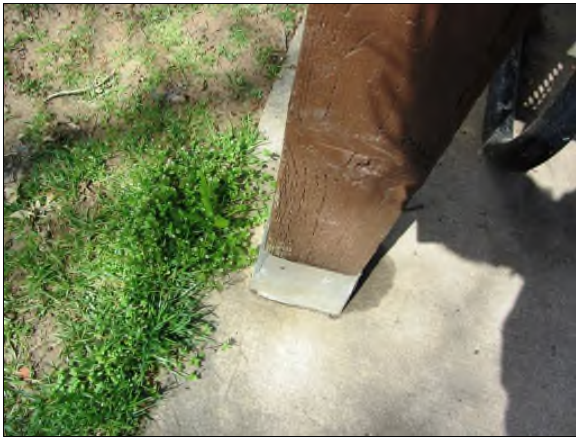
Photo #81. Shed supports in direct contact with the concrete will result in the posts and the structure as a whole, having a limited economic life.

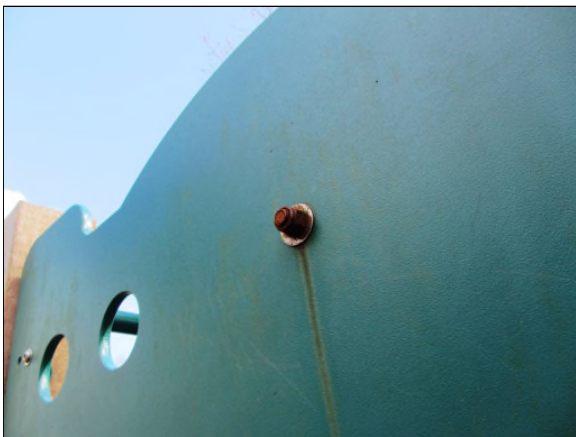
Photo #83. Deteriorated fastener in at the west tot lot.

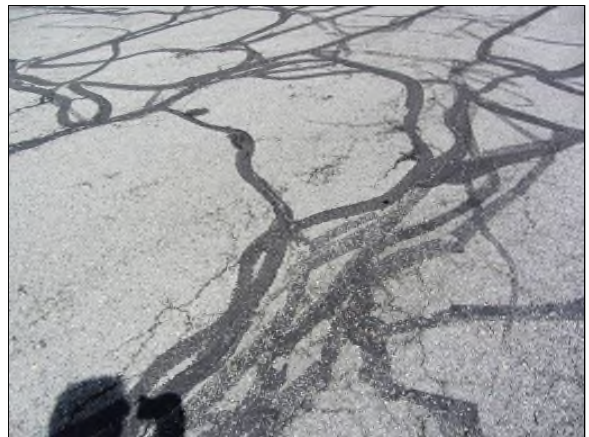
Photo #84. Typical alligatored asphalt pavement with ineffective crack sealing.
